Case Study

Vulcan Materials

Mission Valley – San Diego California.

The Problem – Critical Junction Failure

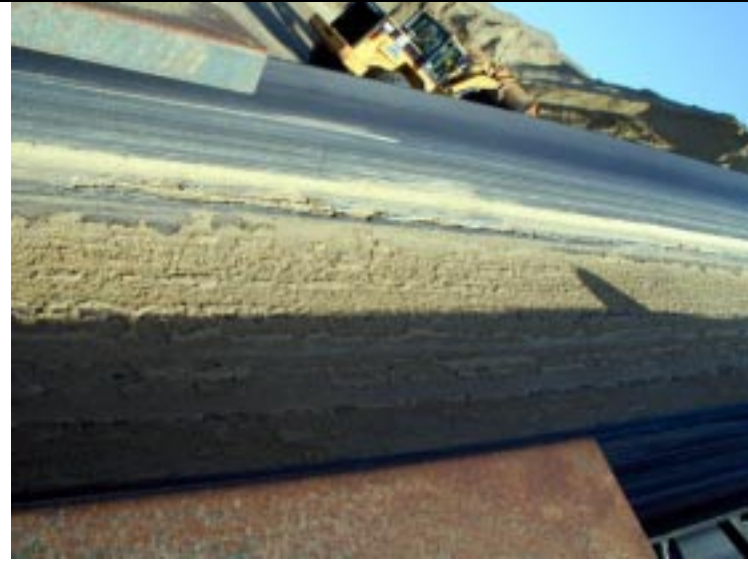
The belt damage consisted of a deep gouge along a 7foot length of a 150foot belt. Material was falling through numerous holes that had resulted.

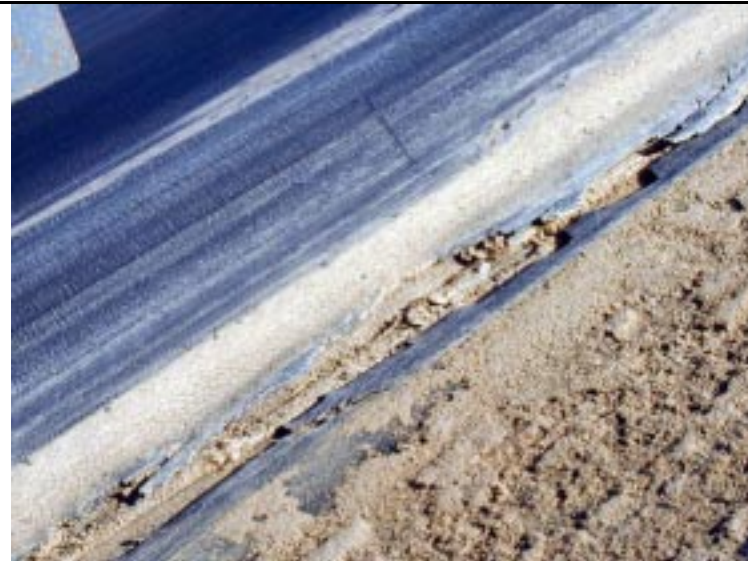
The damage was caused by age and running material with excessive weight over a belt with an idler configuration designed to handle a lighter load.
