## HERCULES-XHD Extra Heavy Duty Impact Bars

### Project: TATA STEEL JODA MINES

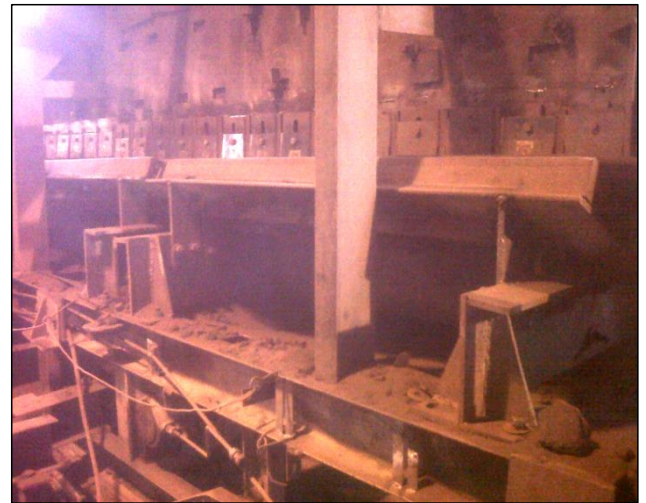
*Impact beds that were earlier in use*

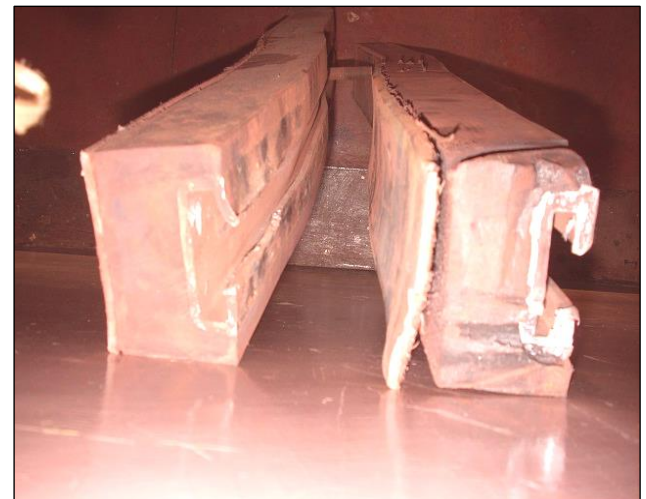
Thejo was given the opportunity to study and submit a proposal to resolve the issue. Our site engineers were deployed to the site and all related parameters collected, communicated to the Engineering & design team. With the help of simulation software, the team developed a customised sturdy Extra Heavy Duty Impact bed. However, the standard heavy duty Impact Bars showed premature failure. The heavy impact forces resulted in the Aluminium fixing tracks of the impact bars getting badly disfigured/damaged, and thereby the UHMWPE debonding from the Rubber base.

*Damaged Impact Bars*

A completely new Extra Heavy Duty Impact Bar was then designed, to withstand the severe impact forces. Aluminium reinforcement was replaced by a more sturdy Steel reinforcement with extra anchoring. The rubber compound was modified to improve the dampening effects.

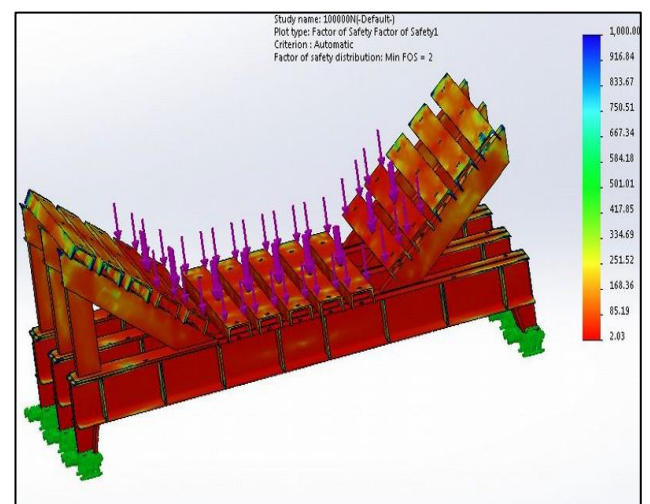
*Impact Bed Load Simulation*

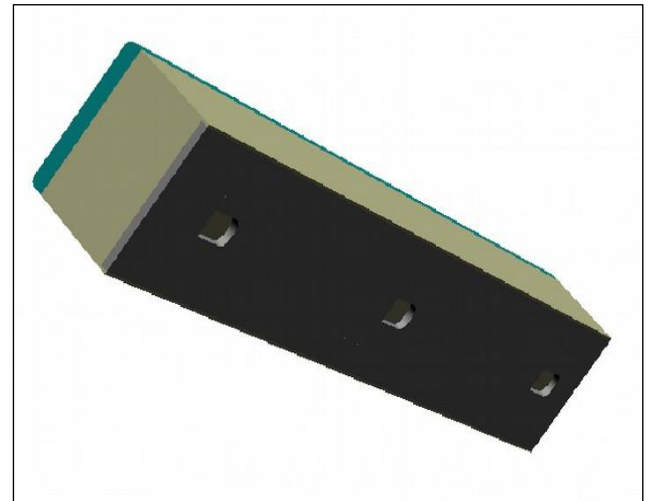
*New Design of Heavy Duty Impact Pad*

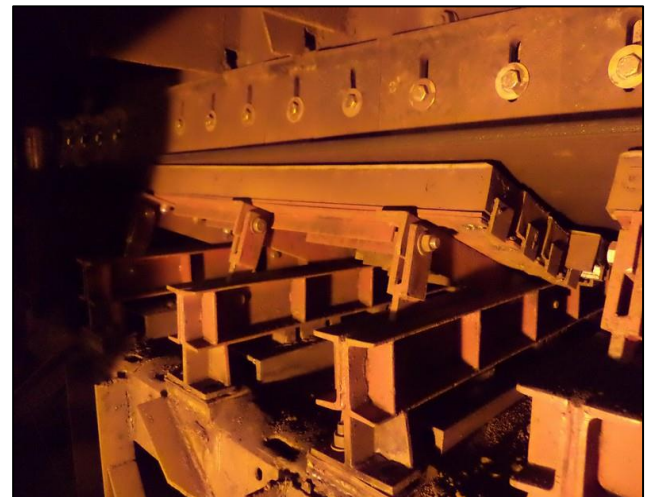
*HERCULES-XHD Impact Bed at site*

Extra Heavy Duty HERCULES-XHD Impact pads installed showed excellent results. The impact bars achieved a service life of four months, i.e double the life of that achieved by other manufacturers.

After seven months of operation the Impact Bed structure indicated signs of fatigue. Special rubber cushions were provided at the mounting area to further dampen the impact loads onto the structure and extend the service life. This modification has since been incorporated as a standard into the Extra Heavy Duty Impact bed design.

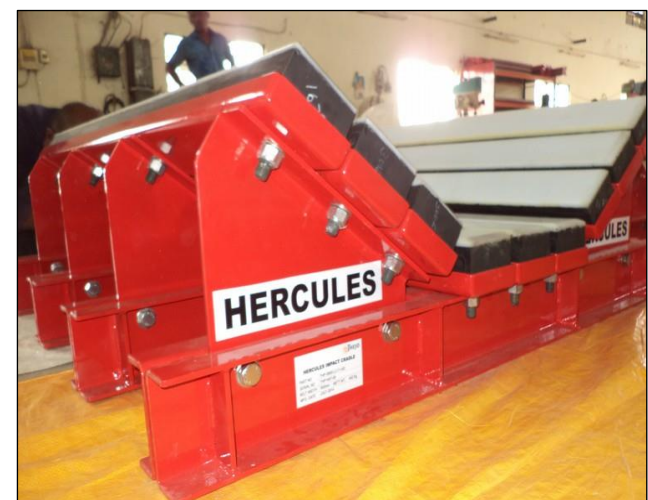
*New HERCULES Impact Bed at Thejo Works*
