TWINLIP Skirt Board Sealing

Project: TATA STEEL, Joda Iron Ore Mines

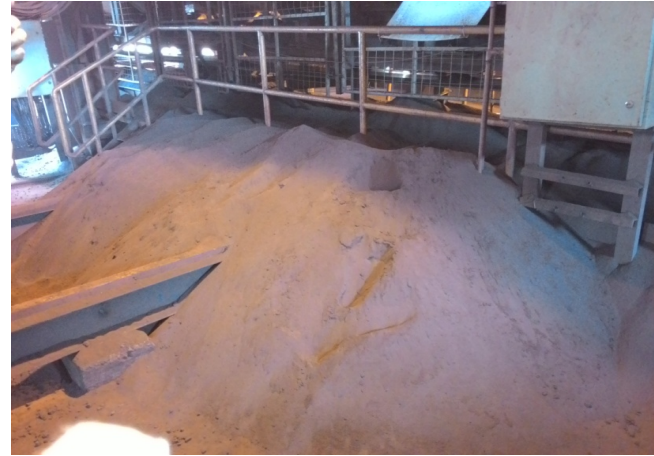
In the Screening Plant of the Joda mine, they had severe spillage problems in the iron ore fines handling conveyors. The plant used segmented type skirt sealing system along with proper belt support systems, however they could not control the spillage through skirt area. The segmented skirt had to be adjusted individually and often could not form a proper sealing between belt and skirt plate leading to heavy spillage of material.

Spillage from conveyor DPC3 skirt area

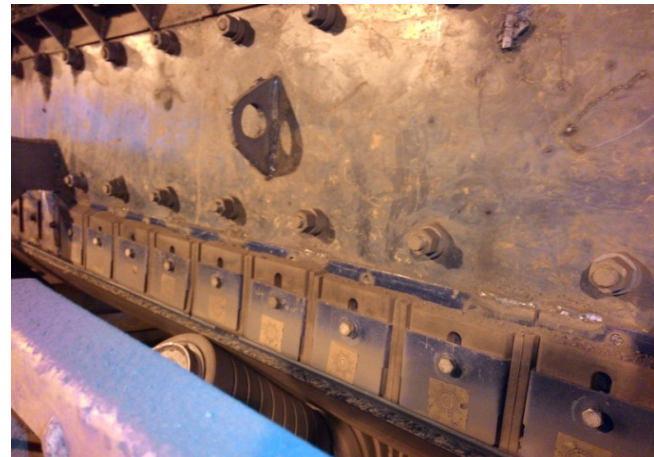
Segmented skirt sealing previously used

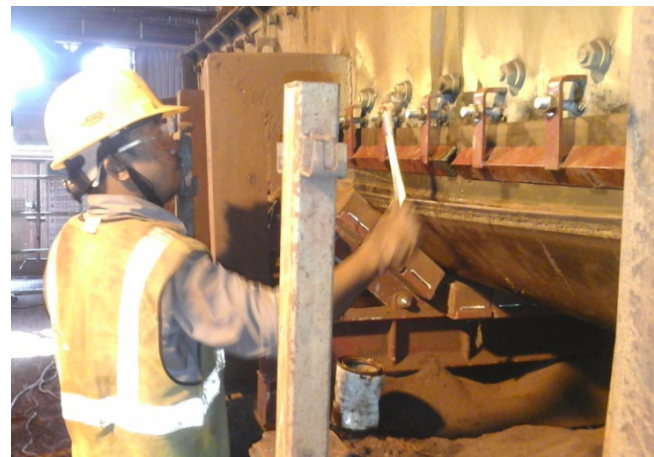
Thejo's technician installing TWINLIP seal

The skirt sealing was supplied promptly and were installed on the conveyor by our expert technicians. The TWINLIP skirt sealing showed excellent spillage control immediately on running the conveyor after installation.

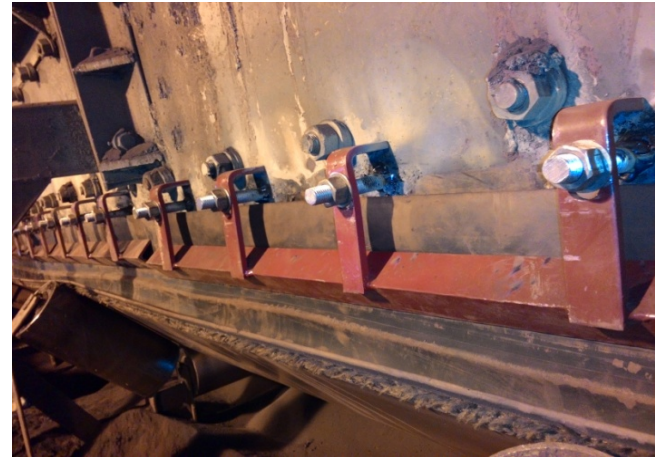
TWINLIP seal installed on the conveyor

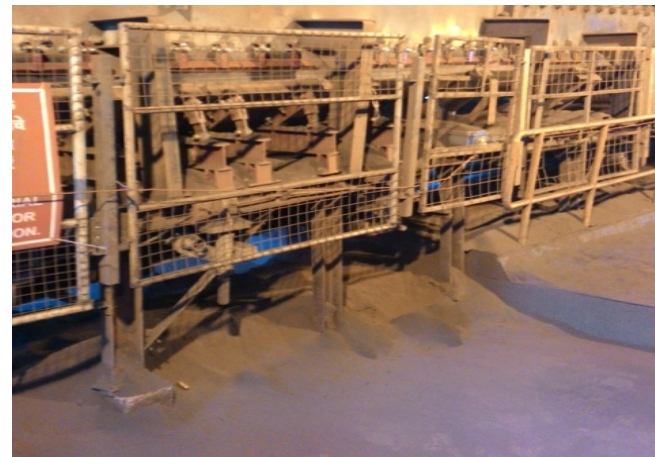
Transfer Point area on the date of installation, after cleaning

To validate the performance of TWINLIP seal, The existing spillages were cleaned it was decided to observe the performance for a weeks time.

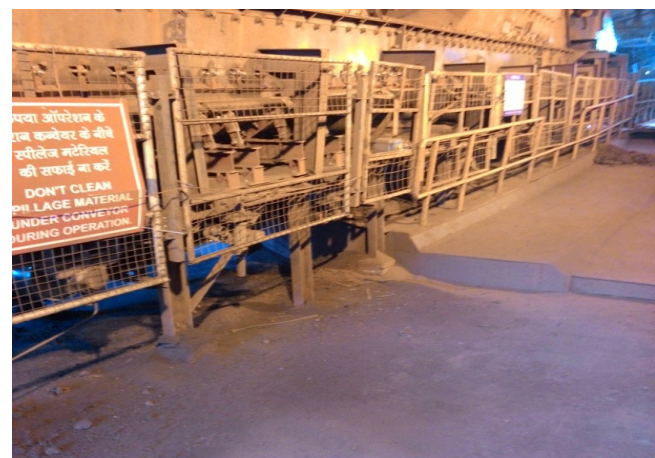
Even after a weeks time, there was negligible spillage only from the skirt area of the conveyor. No adjustment or maintenance was required on the skirt seal till now, from the date of installation.

Transfer Point area after a week from the date of installation
