Belt Cleaners for Slag Processing Plant

Project: PH Transportes, Brazil

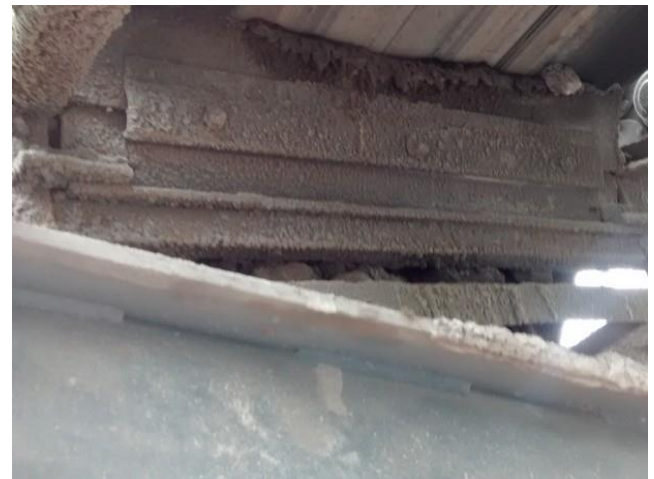
On many occasions the slag and foreign material carried along the belt, got trapped between the belt and cleaner blade, thus damaging both belt and the blade. Slag fines used to build up in the gap between blade segments, resulting in un-even cleaning edge.

Cleaner previously installed on the conveyor

After reviewing the findings, Thejo proposed to install **RAVEN** Primary Cleaner with a single blade. The blade would be smaller in size so that it could be installed clear off slag lumps.

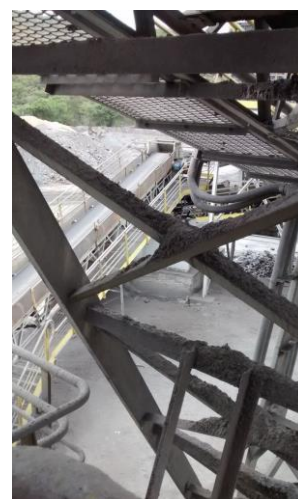
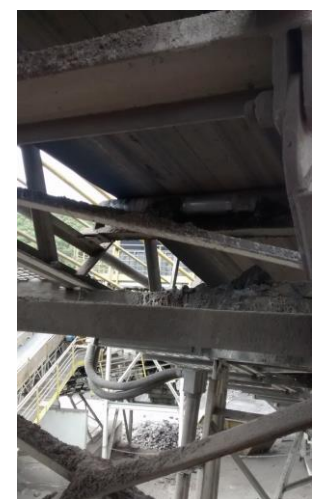
Their Slag Processing Plant in João Monlevade, faced severe carry back problems in the slag handling conveyors. The transfer chutes were small and there was provision to install only one primary cleaner. As the conveyors were slow and the high abrasive nature of slag, the cleaners were installed such that the cleaning blades were away from material flow, in order to reduce wear of the blades. In order to reduce the heat of the slag, water was sprayed to cool it down resulting in high moisture content slag. As a result, the material was very sticky and carry back was heavy.

Carry back material deposited on the on the conveyor structure

Considering the amount of moisture, it was also proposed to install a **CONDOR PD** secondary cleaner. Both the cleaners would have compact construction to allow installation in tight space. The posterior wall of the chute would be modified to collect the material cleaned by the secondary cleaner.

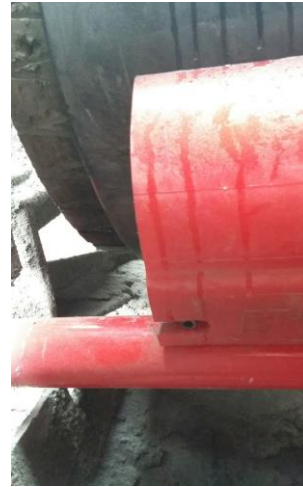
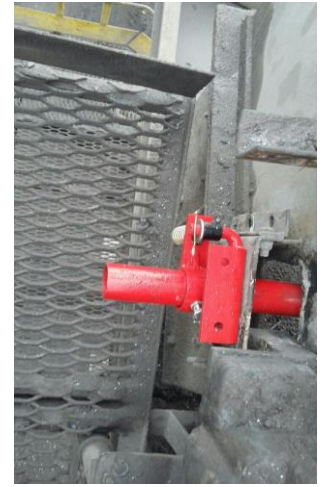
CONDOR Primary Cleaner installed on the conveyor

The belt cleaners started to show off the results almost immediately on starting the conveyor after the installation. The combination of Primary and secondary cleaners reduced the carry back drastically. A small carry back is still observed due to the presence of fine slag. The conveyor stoppages for cleaning have come down. The plant has decided to adopt the system on their remaining conveyors also.

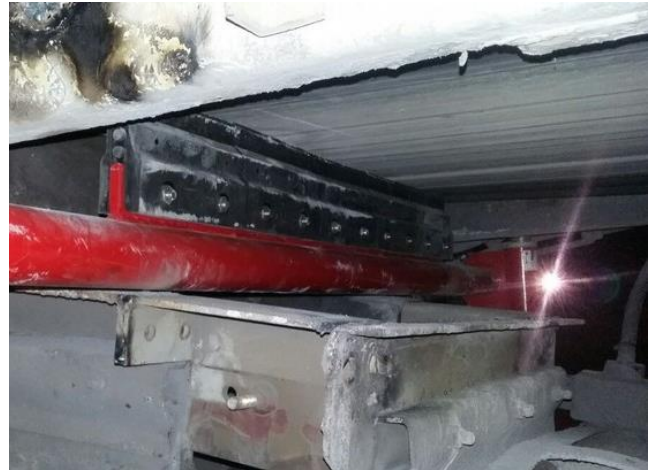
CondorPD Secondary Cleaner installed on the conveyor

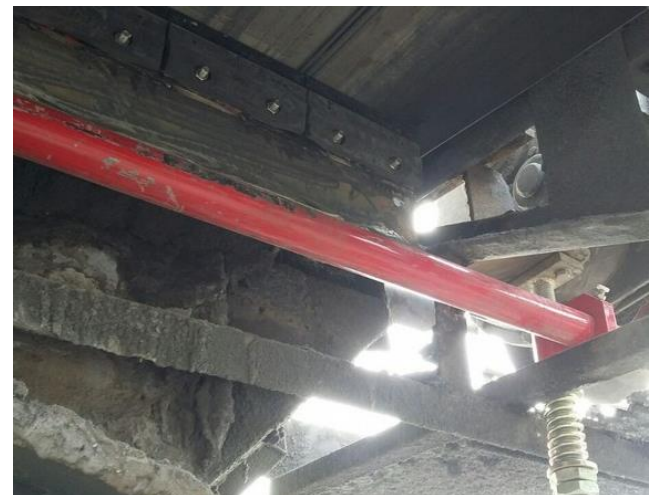
Condor PD Secondary modified at site

The cleaners were supplied in time and installation was carried out under the supervision of our experts. Due to the presence of interference in the small chute, one secondary cleaner was modified at site, to maintain the correct position.
